SSC-294

1. Report No. (18) SSC-294 (19)	2. Government Accession No. AD-A086 049	3. Recipient's Catalog No. (11) May 80
4. Title and Subtitle Ship Structure Committee Project SR-1258 STRUCTURAL DETAILS FAILURE SURVEY		6. Performing Organization (12) 189

Newport News Shipbuilding received a contract on December 6, 1977, from the United States Coast Guard to perform the Ship Structure Committee Project SR-1258. This project titled, "Structural Details Failure Survey, Part II," is a continuation of the Ship Structure Committee Project SR-1232, "Structural Details Failure Survey,"<sup>1</sup> completed in June, 1977, by Newport News Shipbuilding. In Part II, structural detail failure data and percentages of failures for twelve families of details were collected from surveys of the midship/cargo sections of thirty-six ships. The thirty-six ships included three ship types, bulk carriers, containerships, and general cargo ships. This project, under the advisorship of the National Academy of Sciences, Ship Research Committee, is intended to extend and confirm the conclusions of the report titled, "In-Service Performance of Structural Details."<sup>1</sup>

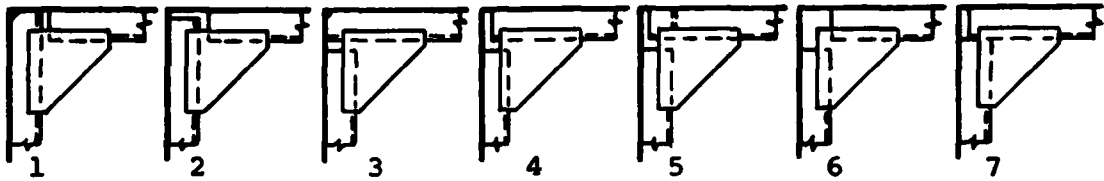
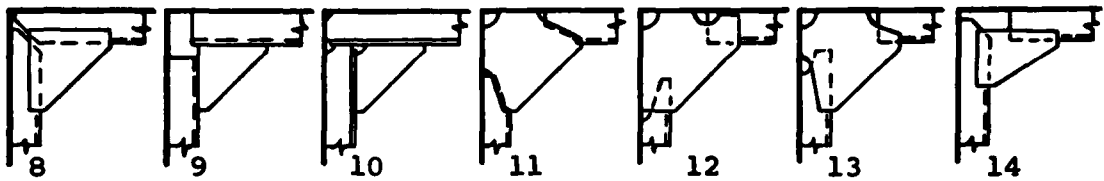
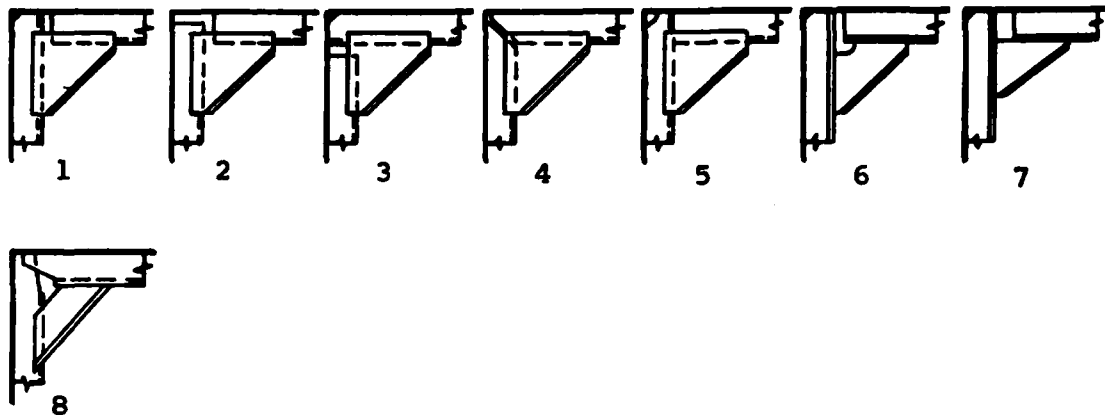
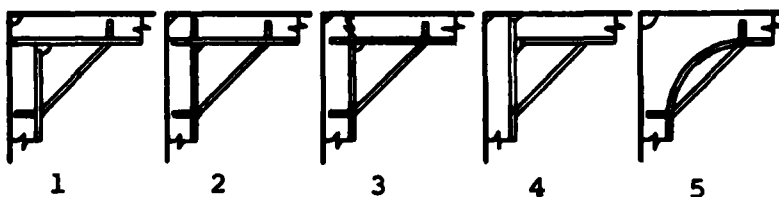
FIGURE 2

Figure 2 shows the 145 variations in configurations included in the 68,586 beam brackets observed in both surveys. The configurations that occur most often in the midship/cargo section of containerhips and general cargo ships are the corner bracket configurations 1-C-1, 1-C-25, 1-C-2, and 1-E-1. They also have a high failure rate, ranking number one, two, four and eight, respectively, in the top ten most prevalent failure details. In the first survey, detail 1-C-1 ranked third and detail 1-C-2 ranked eighth in the same category. Many of the group "C" corner bracket failures could be attributed to instability of the bracket plate panel. This was especially true on containerhips where long spans of shell framing were supported at the ends with unflanged triangular plate with very high breadth/thickness ratios. It was interesting to note that on general cargo ships where wood framing was attached to the shell framing flanges to protect the cargo there were less failures among the group "C" brackets. This was because the tightly wedged wood framing served as intermediate lateral supports for the shell framing and prevented the flanges from tripping under minor local collisions. The wood framing also assisted by forming a grid on the shell framing. Stability was not the problem with the group "E" flanged-plate brackets, because the shell framing or deck framing member usually cracked or buckled near the bracket connection first. Again, the major cause of these severe loads is collisions. It is realized that accidents do happen, but a lot of preventative measures, such as reinforced areas in the ship's hull designated as tug stations, and the use of heavy duty rubber fenders at piers and loading docks, could be applied.

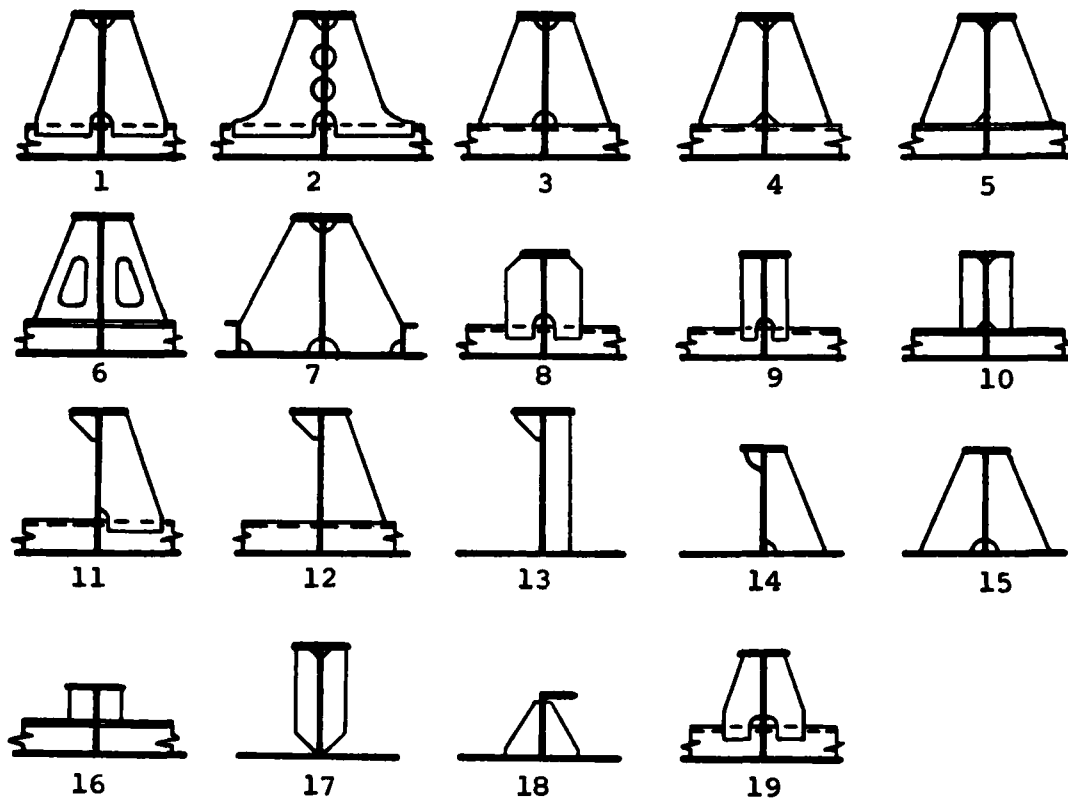
FIGURE 5

The three groups of tripping brackets, containing 82 different configurations, are shown in Figure 5. Sixteen new variations were found in the second survey with eleven belonging to group "C". Group "C" also continued to have the highest failure percentage rate of the three groups, thus, placing four details on the top ten most prevalent failure list and one detail on the top ten highest percentage failure list. Details 2-C-19, 2-C-11, 2-C-7, and 2-C-20 ranked third, fifth, sixth and tenth, respectively, under most prevalent failures. Details 2-A-20 and 2-C-27 were seventh and tenth under highest percentage failures.

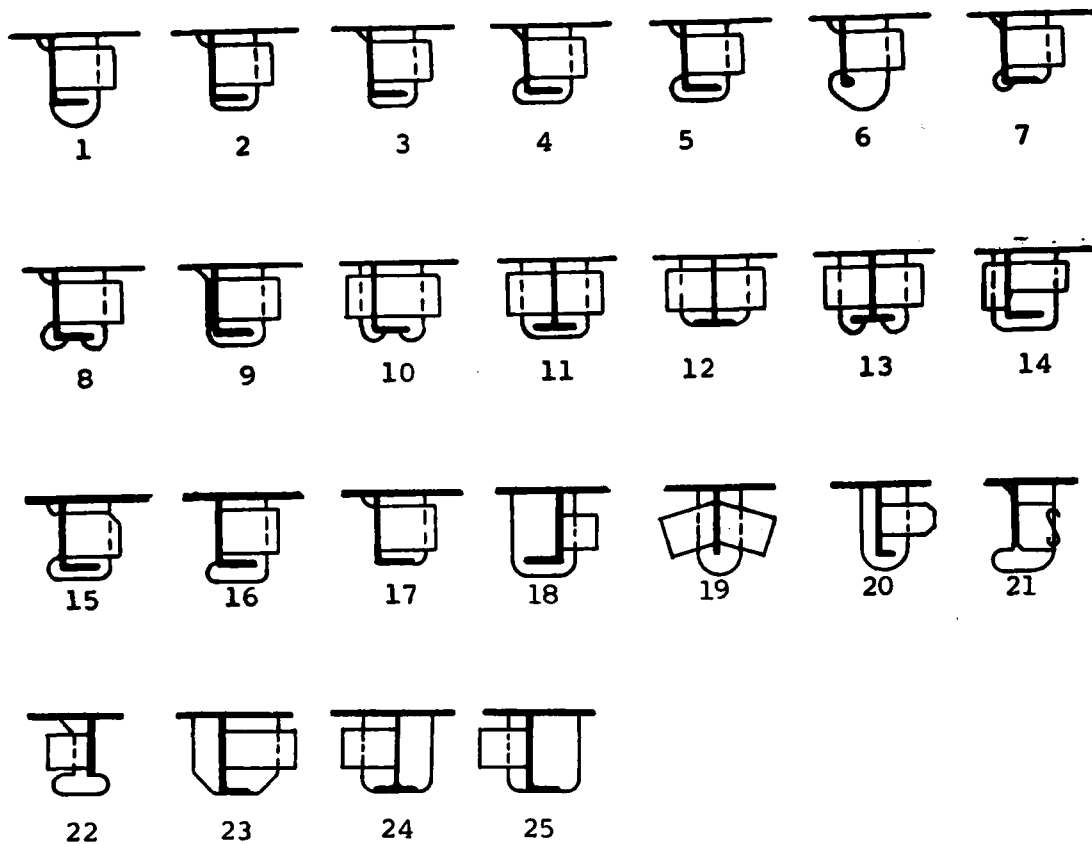
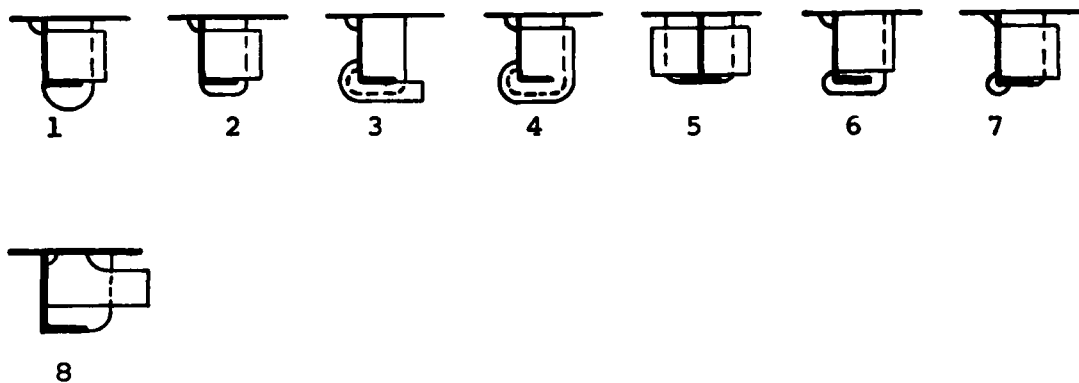
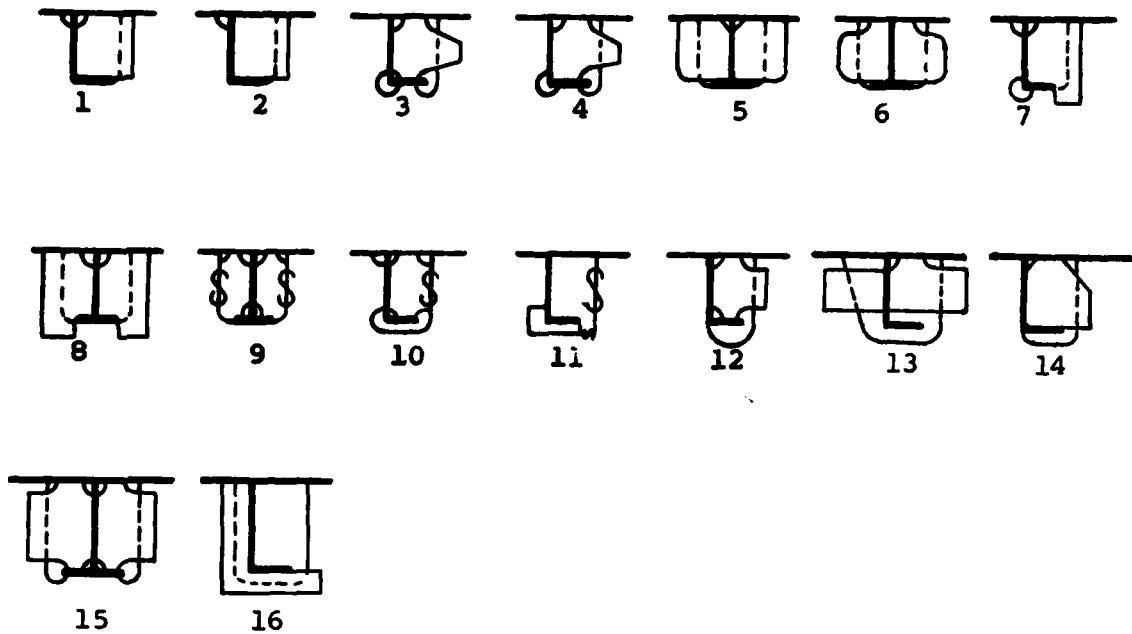
FIGURE 9  
NON-TIGHT COLLAR DETAILS  
FAMILY NO. 3

Of the 4,724 non-tight collar details observed in this thirty-six ship survey there were only five failures. Incomplete welding on detail 3-A-16 resulted in two detail failures on a bulk carrier while poor workmanship and bad welding accounted for three failures of detail 3-A-25 on a containership. Thirteen new variations in configurations were observed in this survey, thus resulting in an overall total of forty-nine configurations for the three group family. Figure 9 shows the forty-nine configurations, and Table 6 summarizes the results.
